THE POROS BUILDING

Section 00 : Excavation Summary  
February, 1950

THE FIVE WESTERN ROOMS

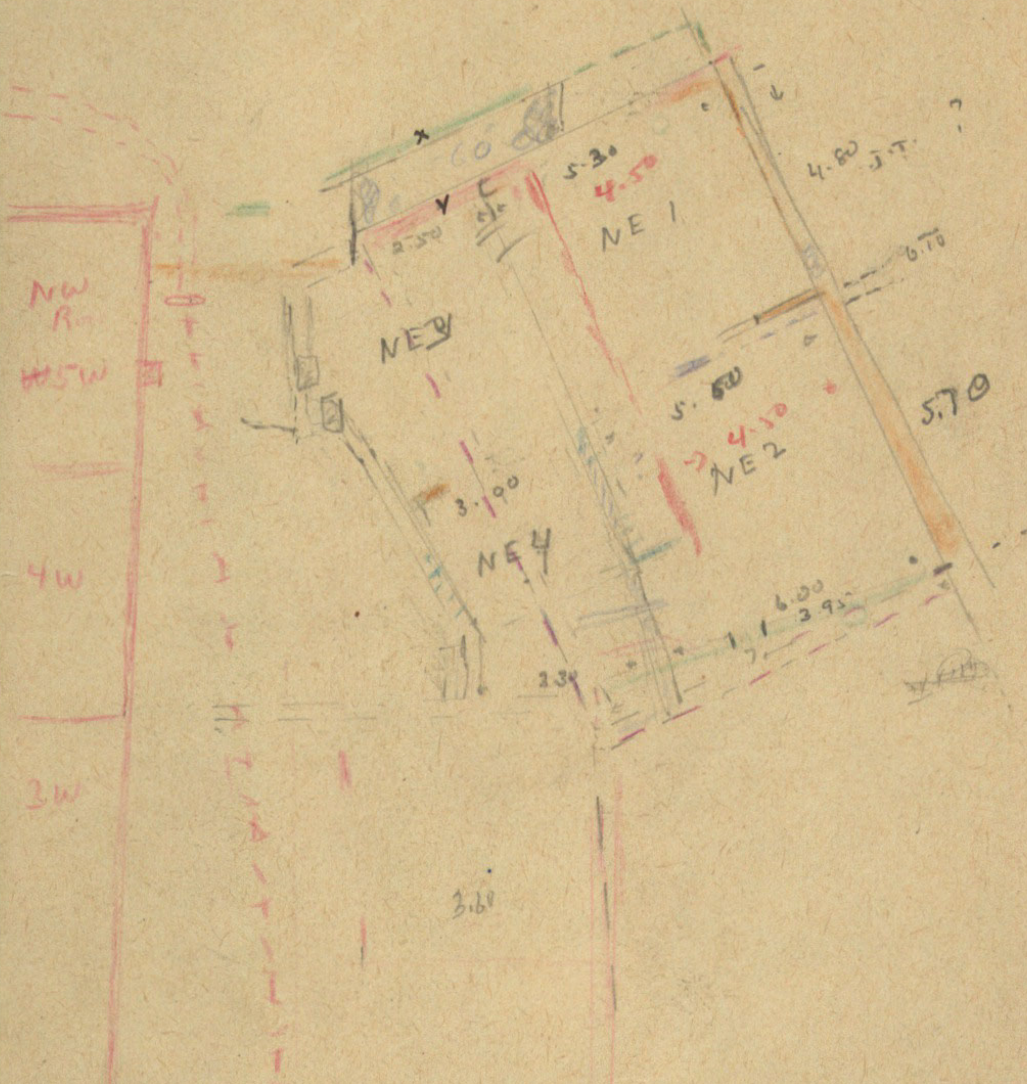
Pr NORTH EAST ANNEY

Pre Pous Bldg

Mid level (Pous Bldg?)  
reced  
washed by manual work  
42?
